SLICKENSIDES ON FAULT PLANE VICINITY OF KOYNA DAM India	
Project No. 14087A	Figure 4-9
Woodward-Clyde Consultants	Page 134

4.4 EUCUMBENE, TALBINGO, AND BLOWERING
RESERVOIRS, AUSTRALIA

4.5 LAKE BENMORE, NEW ZEALAND

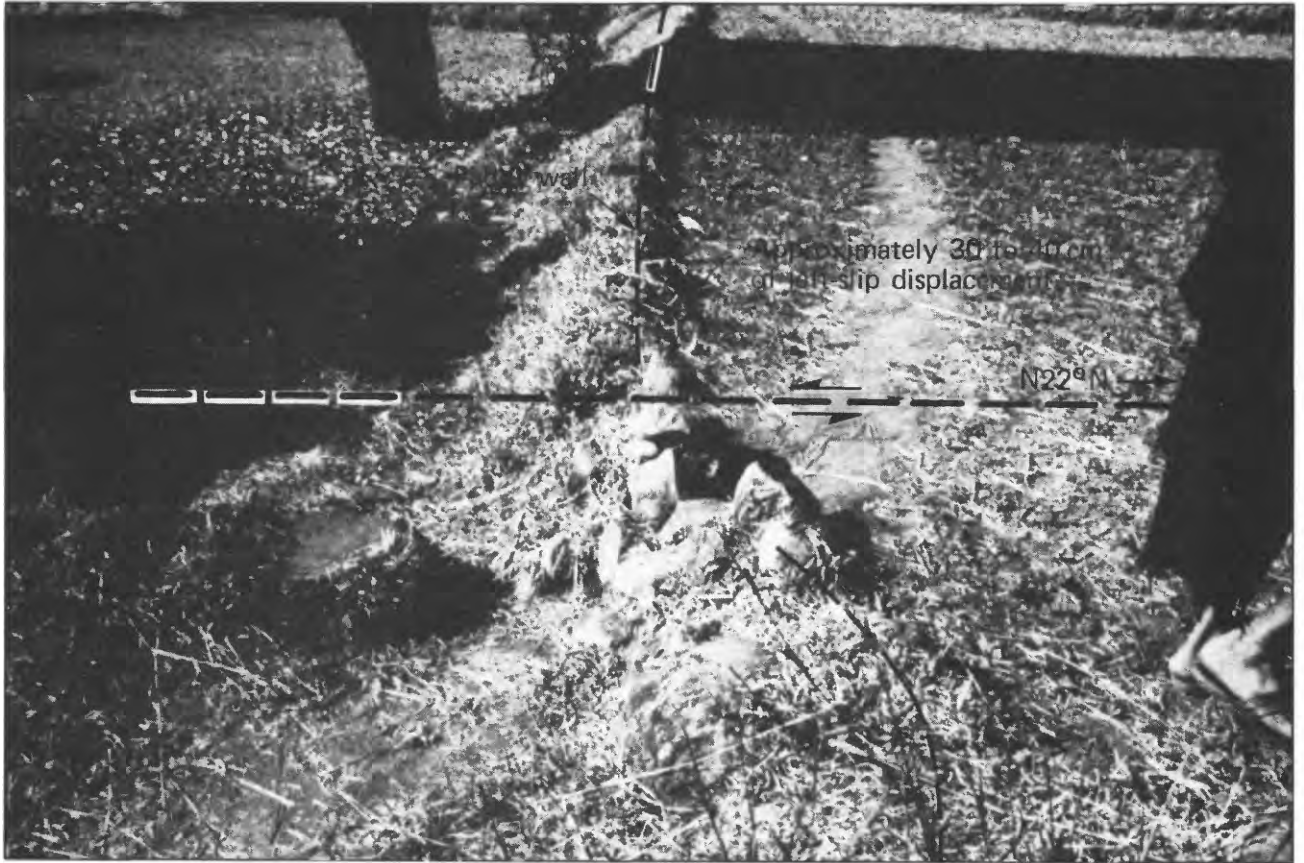
OFFSET PADDY WALLS ALONG
ALIGNMENT OF GROUND CRACKING
India

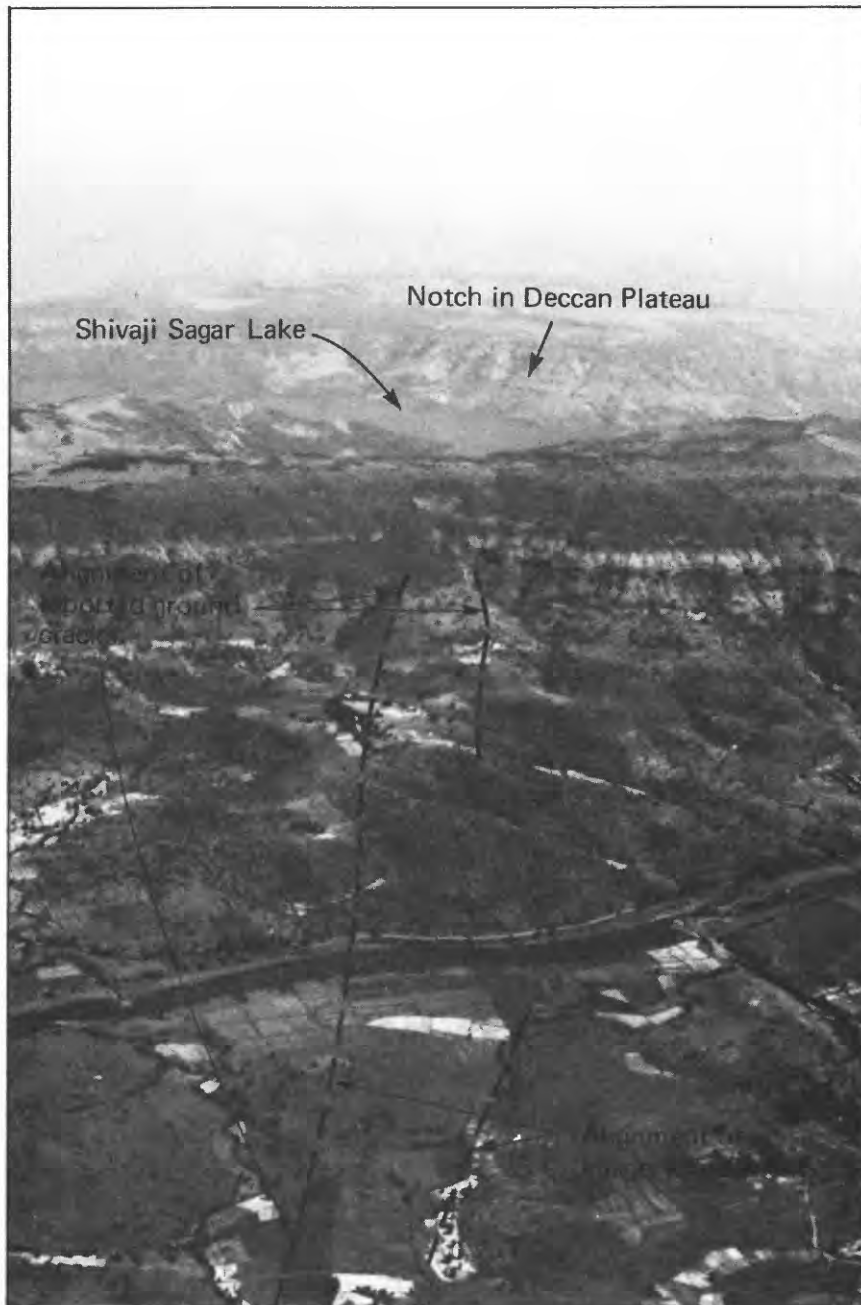
TOPOGRAPHIC NOTCH IN DECCAN PLATEAU
ALONG ALIGNMENT OF GROUND CRACKS
VICINITY OF KOYNA DAM
India

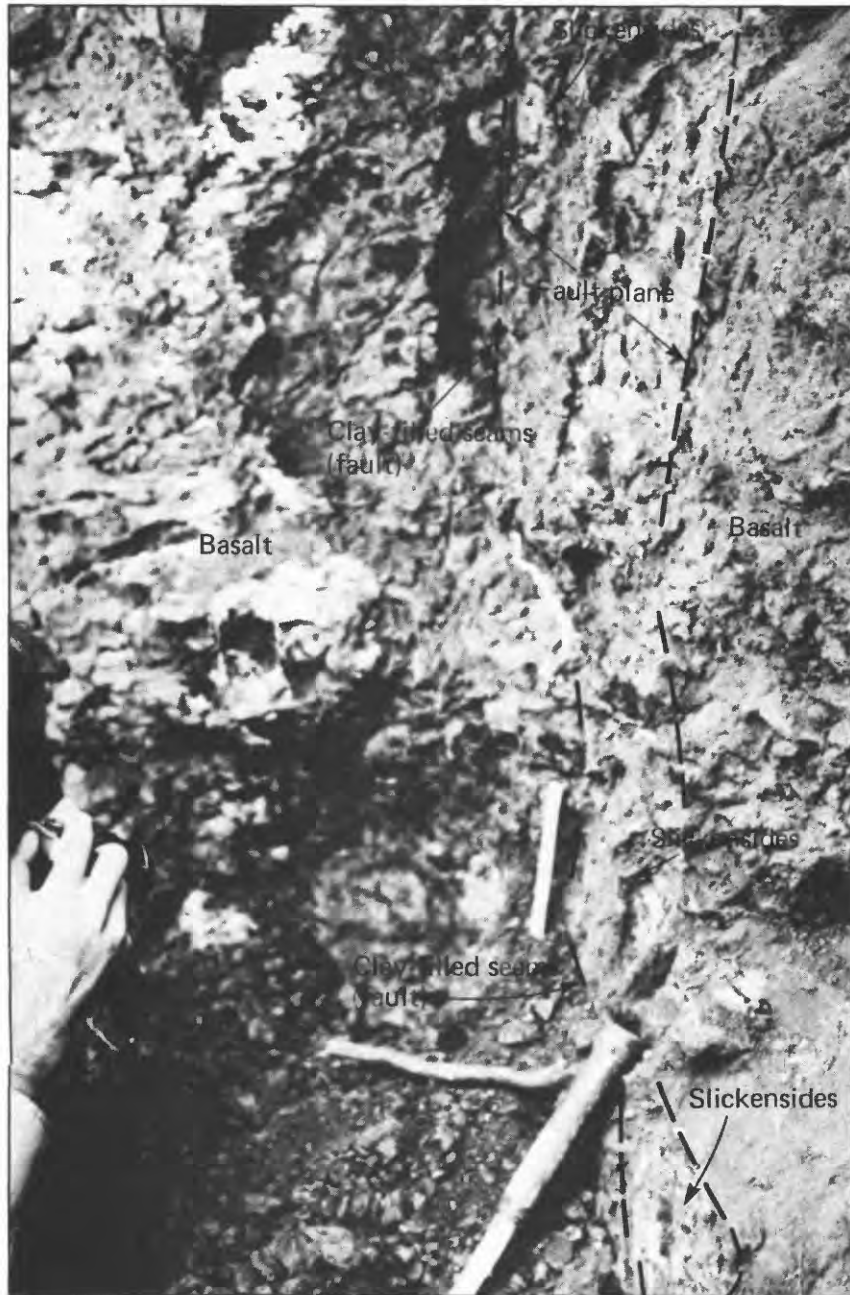
Between the Rain Temple and the Koyna River, the zone of ground cracks crossed two stream drainages. The southern-most drainage and the Koyna River bank both were examined for evidence of faulting, but none was observed. In the northern drainage, however, a fault was observed within or adjacent to the reported zone of ground cracking (Figure 4-6). The fault was located in the northeast bank of a small stream drainage south of the Koyna River (Figure 4-8). Its orientation was N35°E and nearly vertical. Close inspection of the fault showed two distinct near-vertical shears in weathered basalt. The upper shear has a strike of N48°E and dips 79°NW. The lower shear strikes N35°E and dips 83°N. Both shear zones contain zones of clay up to 8 cm thick. The surface of the margin of the clay zone and other planes within the clay are polished. Slickensides were observed on some planes and on the edge of a small cobble adjacent to and in contact with the clay zone. A polished pebble was found in the clay zone with the long direction of the pebble oriented parallel to the grooves in the slickensided clay planes (Figure 4-9). Well-defined manganese-stained slickensided planes were measured to have a strike of 35°E and a rake of 31°SW. The clay-filled zone was traceable for 1.6 m from the base of the stream bank upward through weathered basalt to near the ground surface where slumped reddish brown soil (pebbly colluvium) obscured the structure, as shown in Figures 4-8 and 4-9.

FAULT PLANE EXPOSED IN
BEDROCK ALONG RIVER BANK
VICINITY OF KOYNA DAM
India

Slickensides

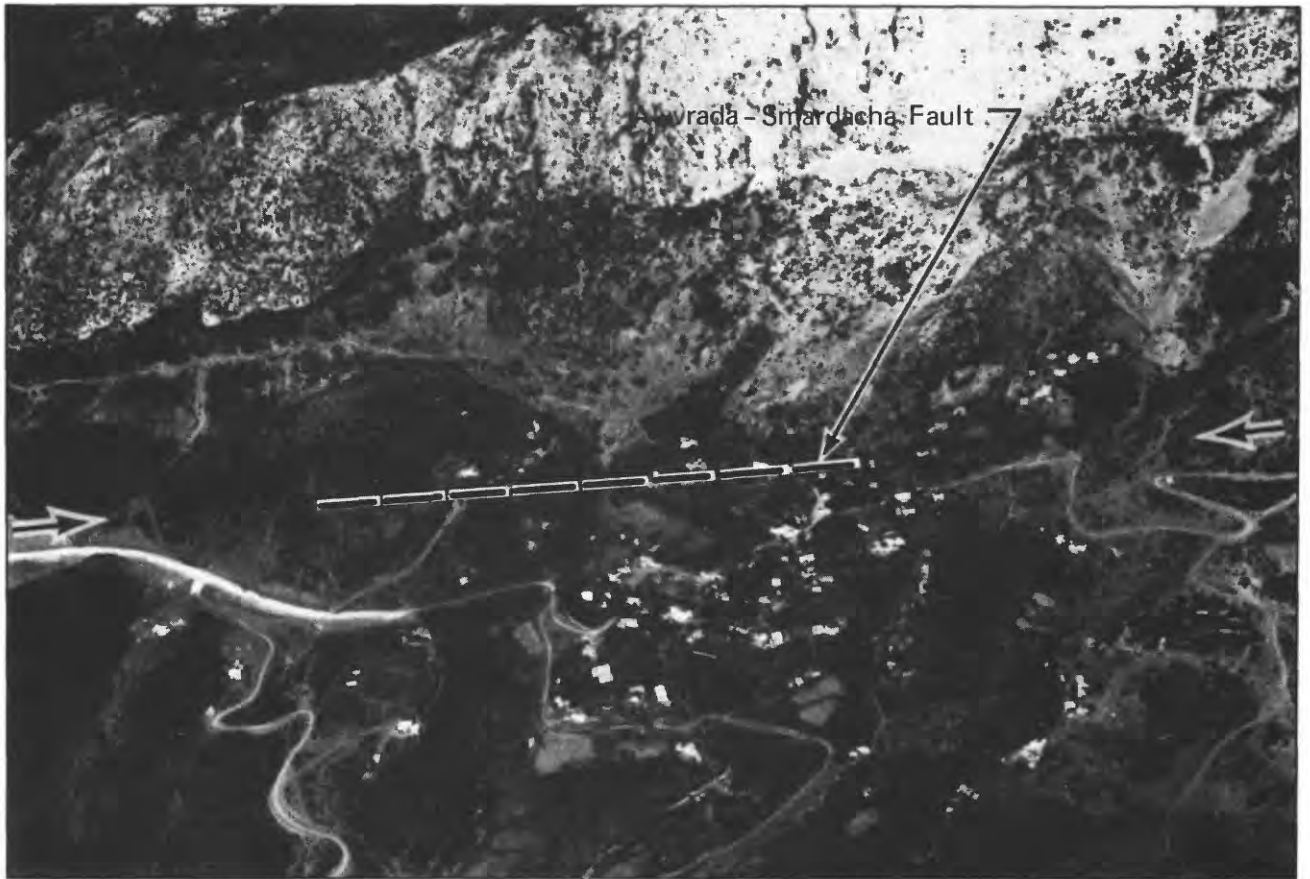
Figure 4-21
Page 163

View is to the northwest

AERIAL VIEW OF ALEVRADA-
SMARDACHA FAULT THROUGH
THE VILLAGE OF ALEVRADA
Greece

- 4) The Alevrada-Smardacha fault is a prominent northeast-southwest trending, high-angle fault of at least 15 km length between Petrona and the Smardacha Bridge. Normal displacement down to the southeast was observed, as was sinistral and dextral displacement. Extensive landsliding occurred north of the village of Alevrada during the 1966 earthquake. The landslides apparently were triggered by the earthquake. No ground cracks were identified along the Alevrada-Smardacha fault in the Alevrada area. Clear topographic features and recent seismicity suggest this fault may be active.

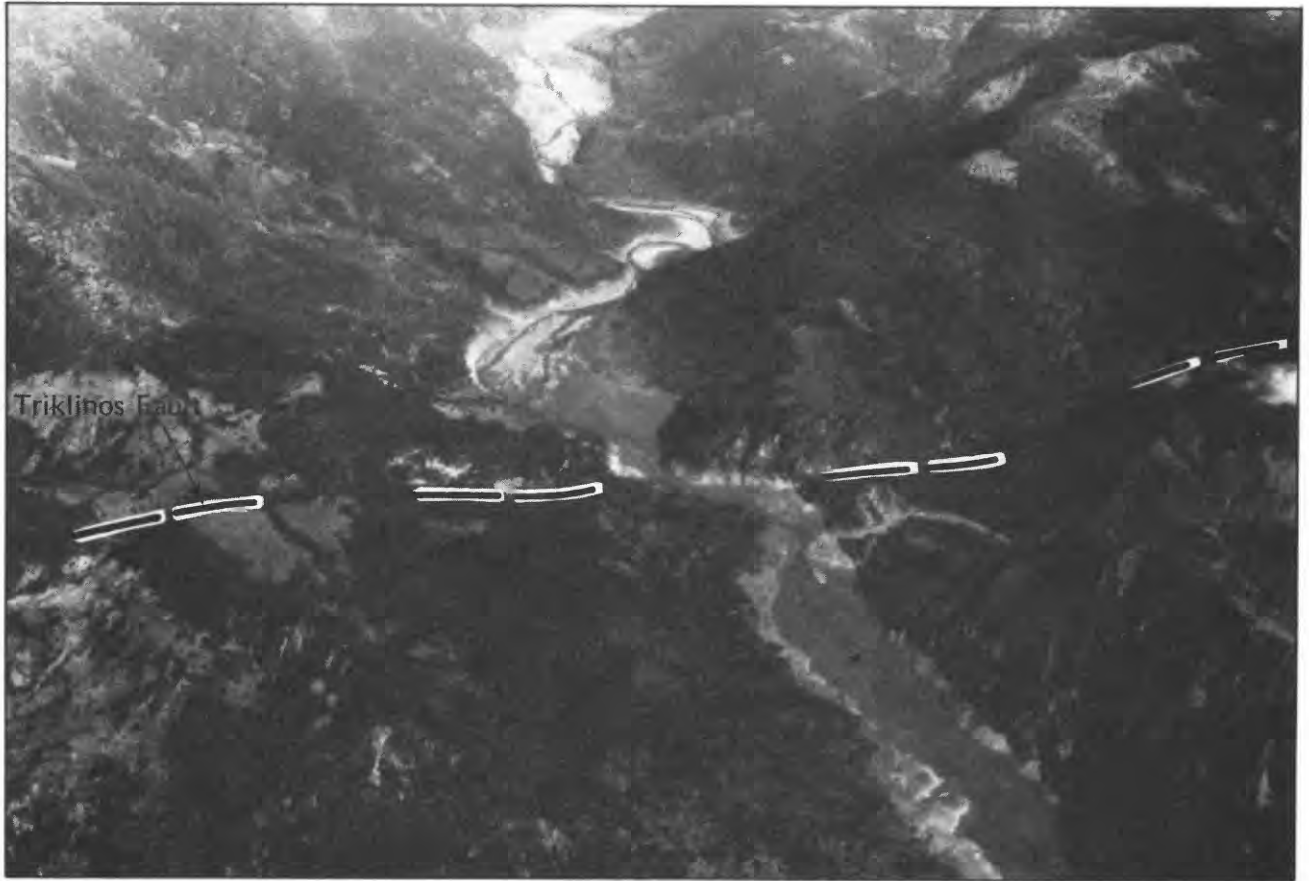
Figure 4-22
Page 165

was observed to trend from the Megdhoyas arm of the reservoir, through the stream drainage from Frangista, which has had a sinistral displacement of approximately a hundred meters (Location D, Figure 4-14; Figure 4-22). The linear feature continues northwestward near the prominent scarp shown on Figure 4-15 and subparallel to the trend of the Pindus fault in this area of the lake region. Northwest of the village of Paleohoria, the Pindus thrust fault trends more northerly while the linear feature continues across the Acheloos arm of the reservoir and offsets the Alevrada-Smardacha fault with sinistral displacement (Location E, Figure 4-14; Figure 4-23). The linear trend was observed to continue northwestward to the village of Triklinos beyond which it could not be observed.

The Triklinos fault's observed length is at least 25 km. The fault trends northwest and is inferred to be active, based on the youthful nature of the displaced Frangista drainage. Recurring displacement within the present tectonic stress regime has been inferred to have occurred, resulting in the offset drainage of the stream. The trend of the fault and the sense of displacement agree remarkably well with that postulated by Comninakis and others (1968) (Figure 4-10). Correlation of the field observations and the seismologic calculations is not possible at the present time, but the similarity is notable.

AERIAL VIEW OF SINISTRAL
DISPLACEMENT OF FRANGISTA STREAM
DRAINAGE AT TRIKLINOS FAULT
Greece

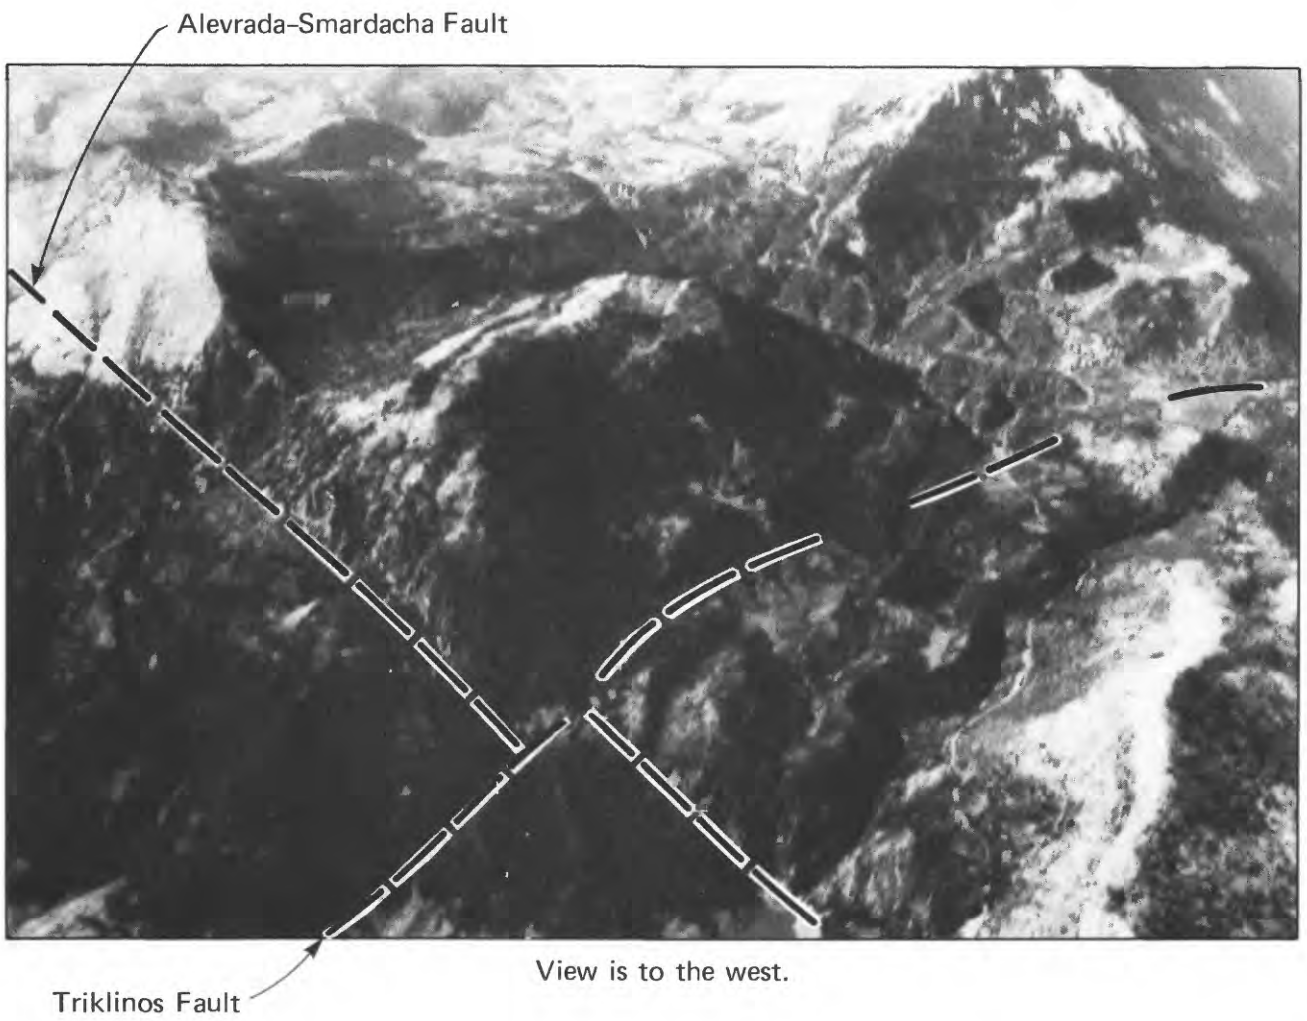
AERIAL VIEW OF SINISTRAL DISPLACEMENT
OF THE ALEVRADA-SMARDACHA FAULT
BY THE TRIKLINOS FAULT
Greece

- 5) The Triklinos fault is a northwest-trending, high-angle fault whose observed length is at least 25 km from the Megdhoyas arm of Lake Kremasta to the village of Triklinos. An offset stream drainage and offset of the Alevrada-Smardacha fault show sinistral displacement of approximately a hundred meters. The youthful nature of the displaced stream demonstrates the recency of fault displacement along this feature and strongly suggests the fault is active.

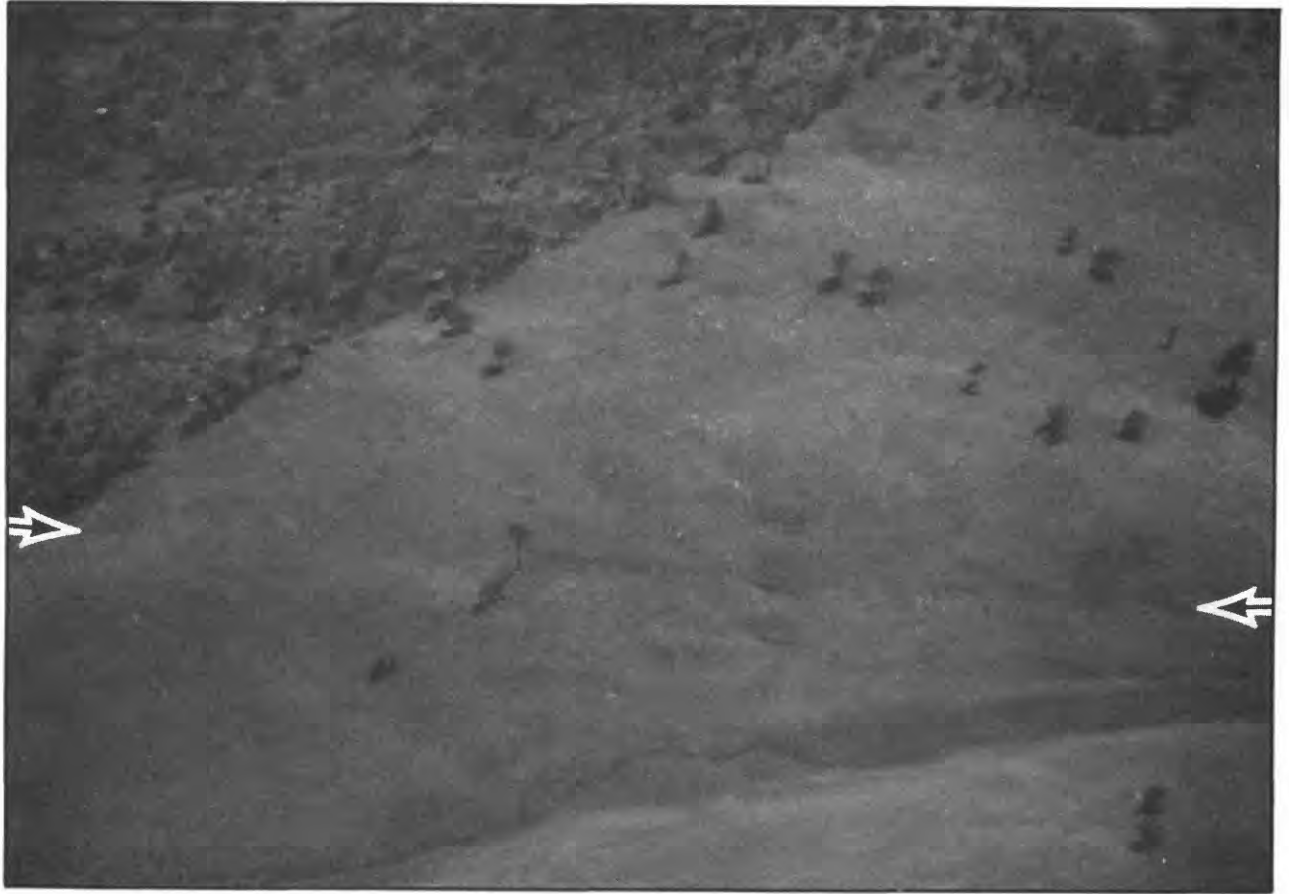
Berridale Wrench Fault - The Berridale wrench fault is a major northwest-trending feature described in the literature as exhibiting approximately 11 km of left-lateral offset and as showing evidence of vertical displacement (Lambert and White, 1965; White and others, 1977). The left-lateral displacement is believed to have occurred during the Devonian period, whereas the inferred vertical displacement apparently has offset basalts of Tertiary age. Clear evidence of this displacement was not observed during field reconnaissance conducted for the study. However, during aerial reconnaissance, the Berridale fault was recognizable on the basis of linear tonal changes in grassy areas, gross changes in vegetation, linear sidehill depressions, and aligned saddles (Figure 4-29).

Lambert and White (1965) state that the Berridale fault has produced linear scarps in alluvium southeast of Berridale, where the current reconnaissance started. They also show an aftershock sequence in the Berridale area as having a northwest-striking, left-lateral, strike-slip component. Thus, on the basis of stratigraphic, geomorphic, and seismic evidence, the Berridale fault was classified as active for the purposes of this study.

View is to the northeast. Arrows denote break in slope along Berridale fault.

BERRIDALE WRENCH FAULT VICINITY OF LAKE EUCUMBENE New South Wales, Australia	
Project No. 14087A	Figure 4-29
Woodward-Clyde Consultants	Page 183

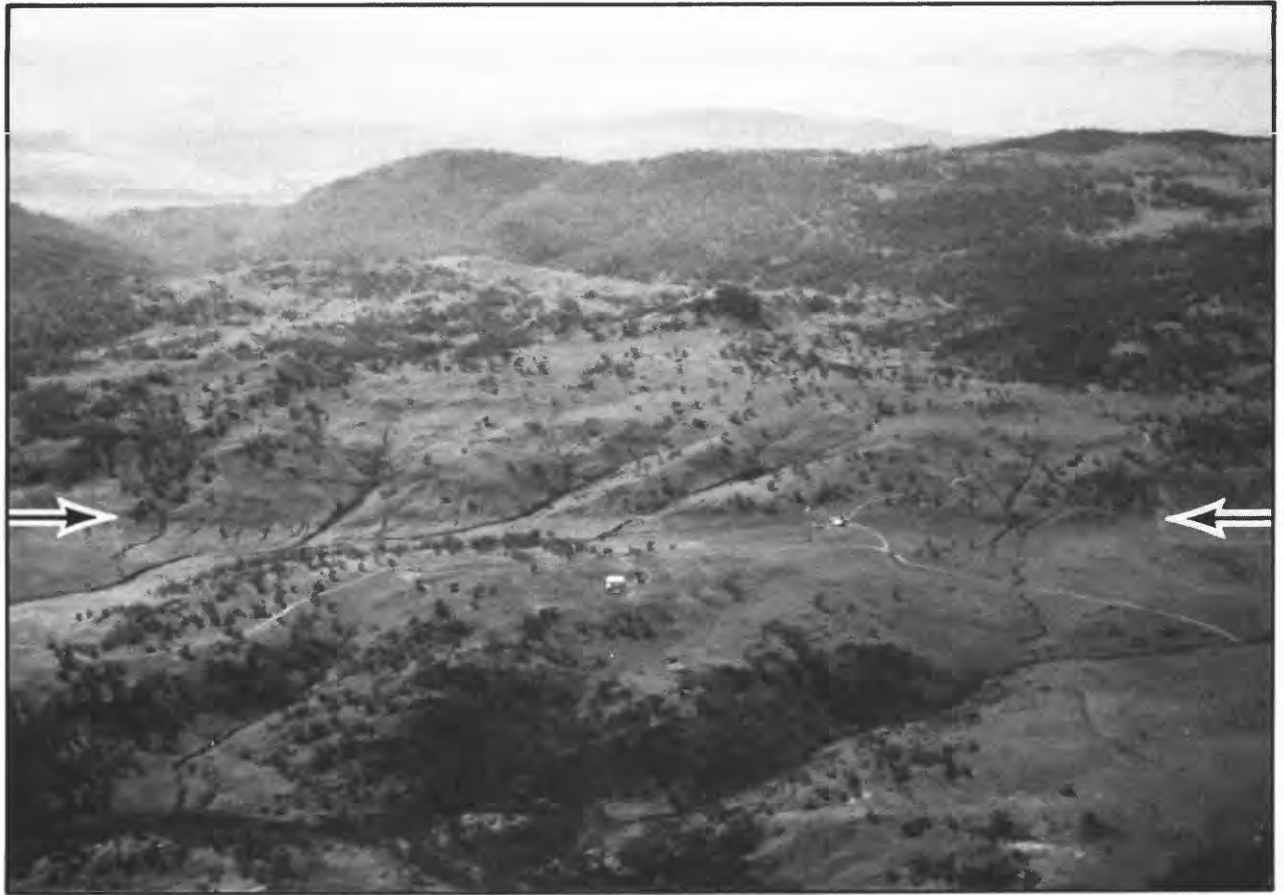
Figure 4-30

View is to the east, across Jindabyne fault near Hollins Crossing. The prominent topographic expression is shown.

JINDABYNE THRUST FAULT
VICINITY OF LAKE EUCUMBENE

During the field reconnaissance for the current study, the mapped trace of the Jindabyne fault was observed as characterized by alignments of linearly grooved saddles, vegetational changes, and springs. For the purposes of this study, the Jindabyne fault is considered active, based upon the structural relationships.

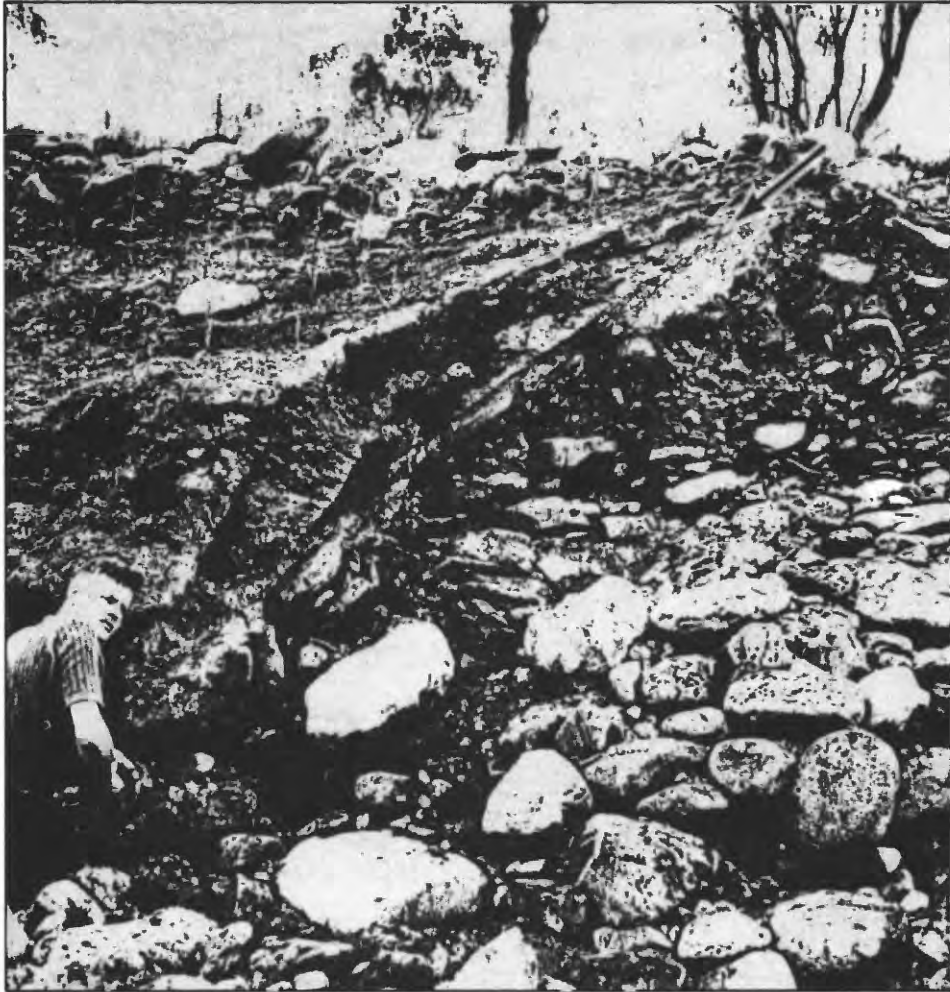
Figure 4-31

Bedrock thrust over gravel, vicinity of Khancoban. Photograph courtesy of Mr. Kenneth R. Sharp, Snowy Mountain Engineering Corporation, Cooma, N.S.W., Australia

KHANCOBAN-YELLOW BOG FAULT
SNOWY MOUNTAINS

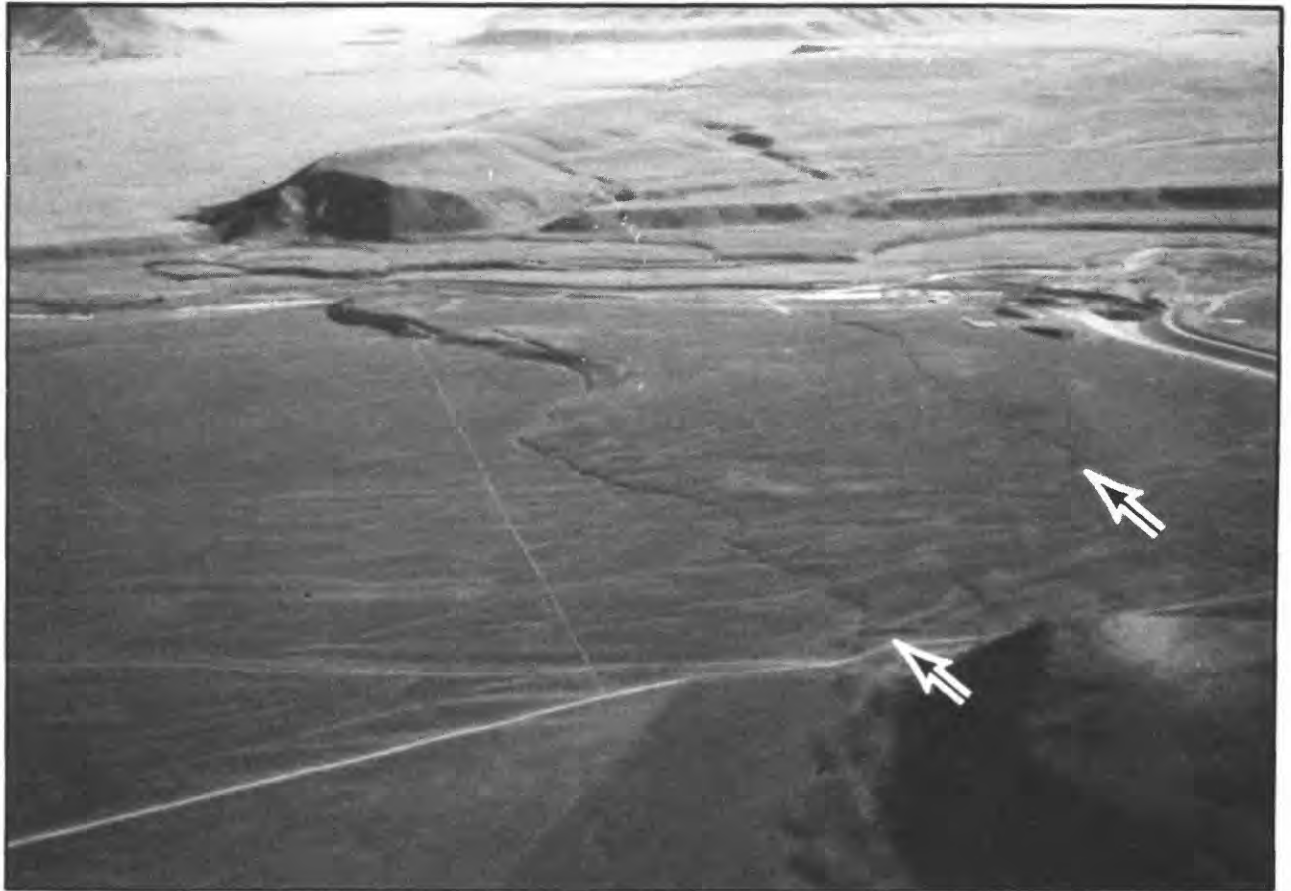
View is to the south, along the Ostler fault zone. Arrows indicate variations in scarp height in Quaternary units of different ages.

OSTLER FAULT ZONE
VICINITY OF LAKE BENMORE
South Island, New Zealand

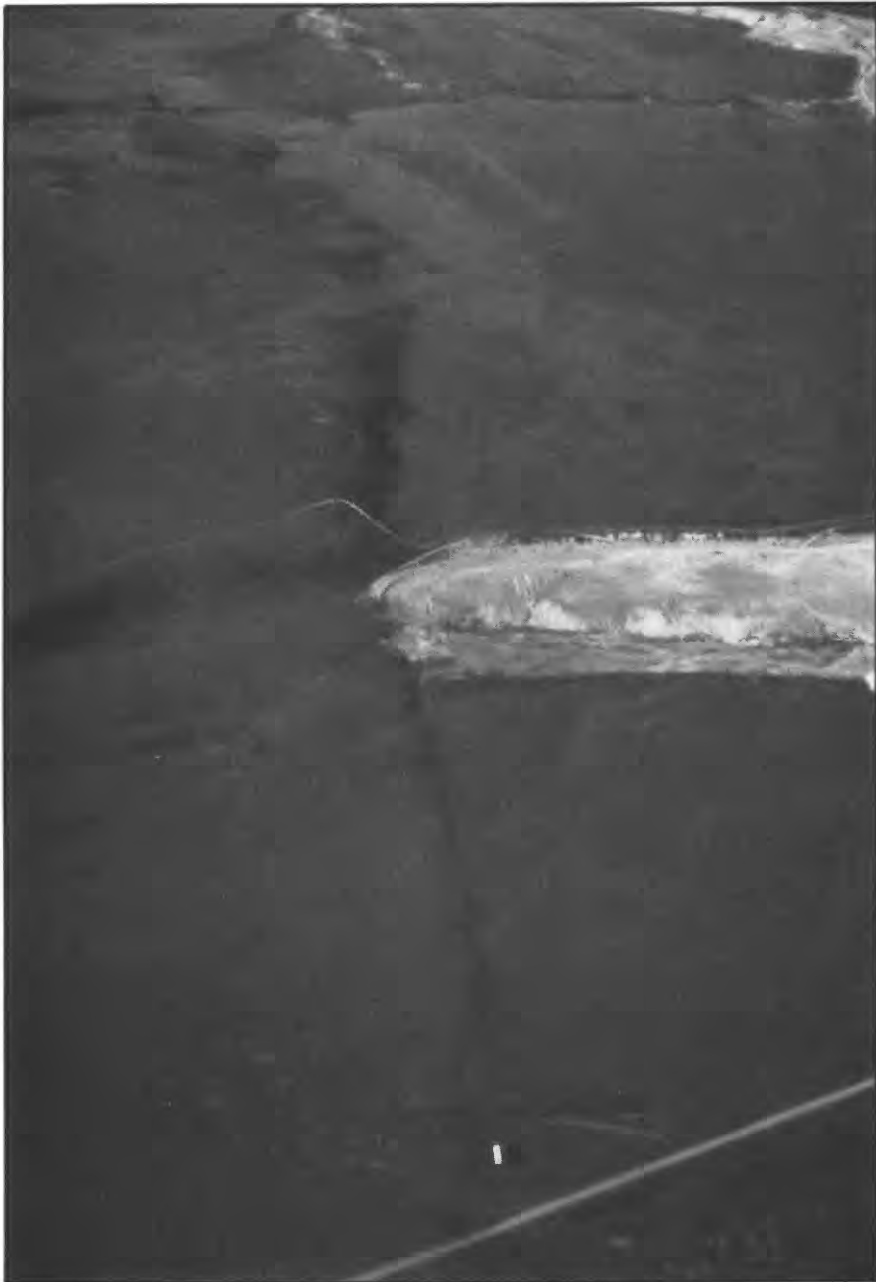
View is to the north, along the Haybarn trace of the Ostler fault zone. The left-lateral drainage offset can be seen near excavation scar.

HAYBARN FAULT VICINITY OF LAKE BENMORE South Island, New Zealand	
Project No. 14087A	Figure 4-38
Woodward-Clyde Consultants	Page 203

For the present study, the surface reconnaissance of the Haybarn trace of the Ostler fault zone found pronounced evidence of left-lateral offset of small drainages. The amount of left-lateral offset appears to be substantially greater than the vertical displacement. This evidence of a strong left-lateral strike-slip offset supports the previously described evidence pointing to the existence of a nearly vertical fault plane. It also supports the focal mechanism interpretation for the December 1978 earthquake. The strongest geomorphic expression suggestive of recurrent offset was seen on the Ruataniwha fault trace, immediately north of the Ohau River. At this location, two fault traces appear to be closely intertwined, producing a scarp-like feature. The results of the present study and of evaluation of the mechanism of the December 1978 earthquake indicate that the Ostler fault zone, which previously had been considered to be a westward-dipping thrust fault, is a nearly vertical, left-lateral strike-slip fault along its eastern portion.

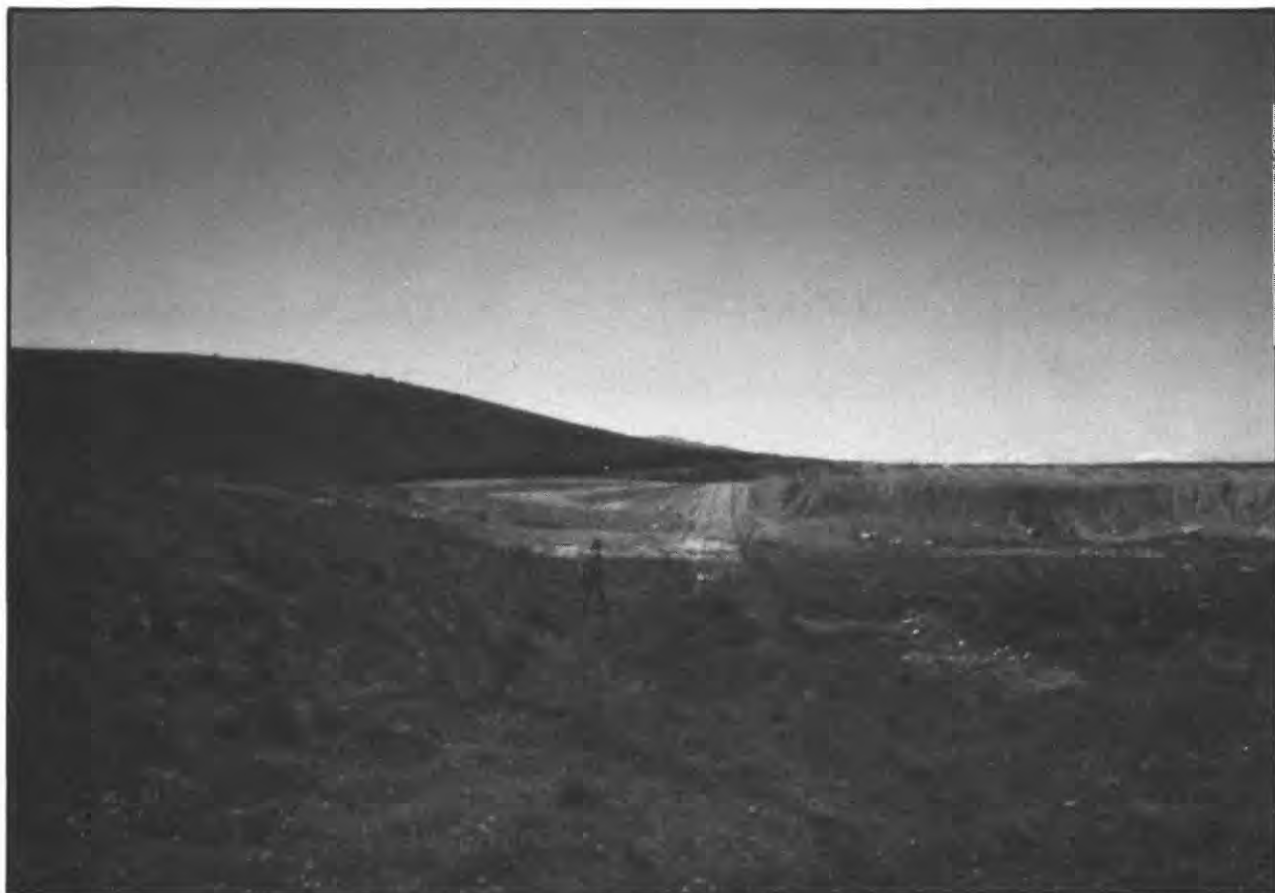
Figure 4-39

View is to the north, along the Haybarn trace of the Ostler fault zone. The degraded fault scarp is visible. Left-lateral offset of small drainage crosses slope adjacent to geologist (in center of photograph).

HAYBARN FAULT
VICINITY OF LAKE BENMORE
South Island, New Zealand

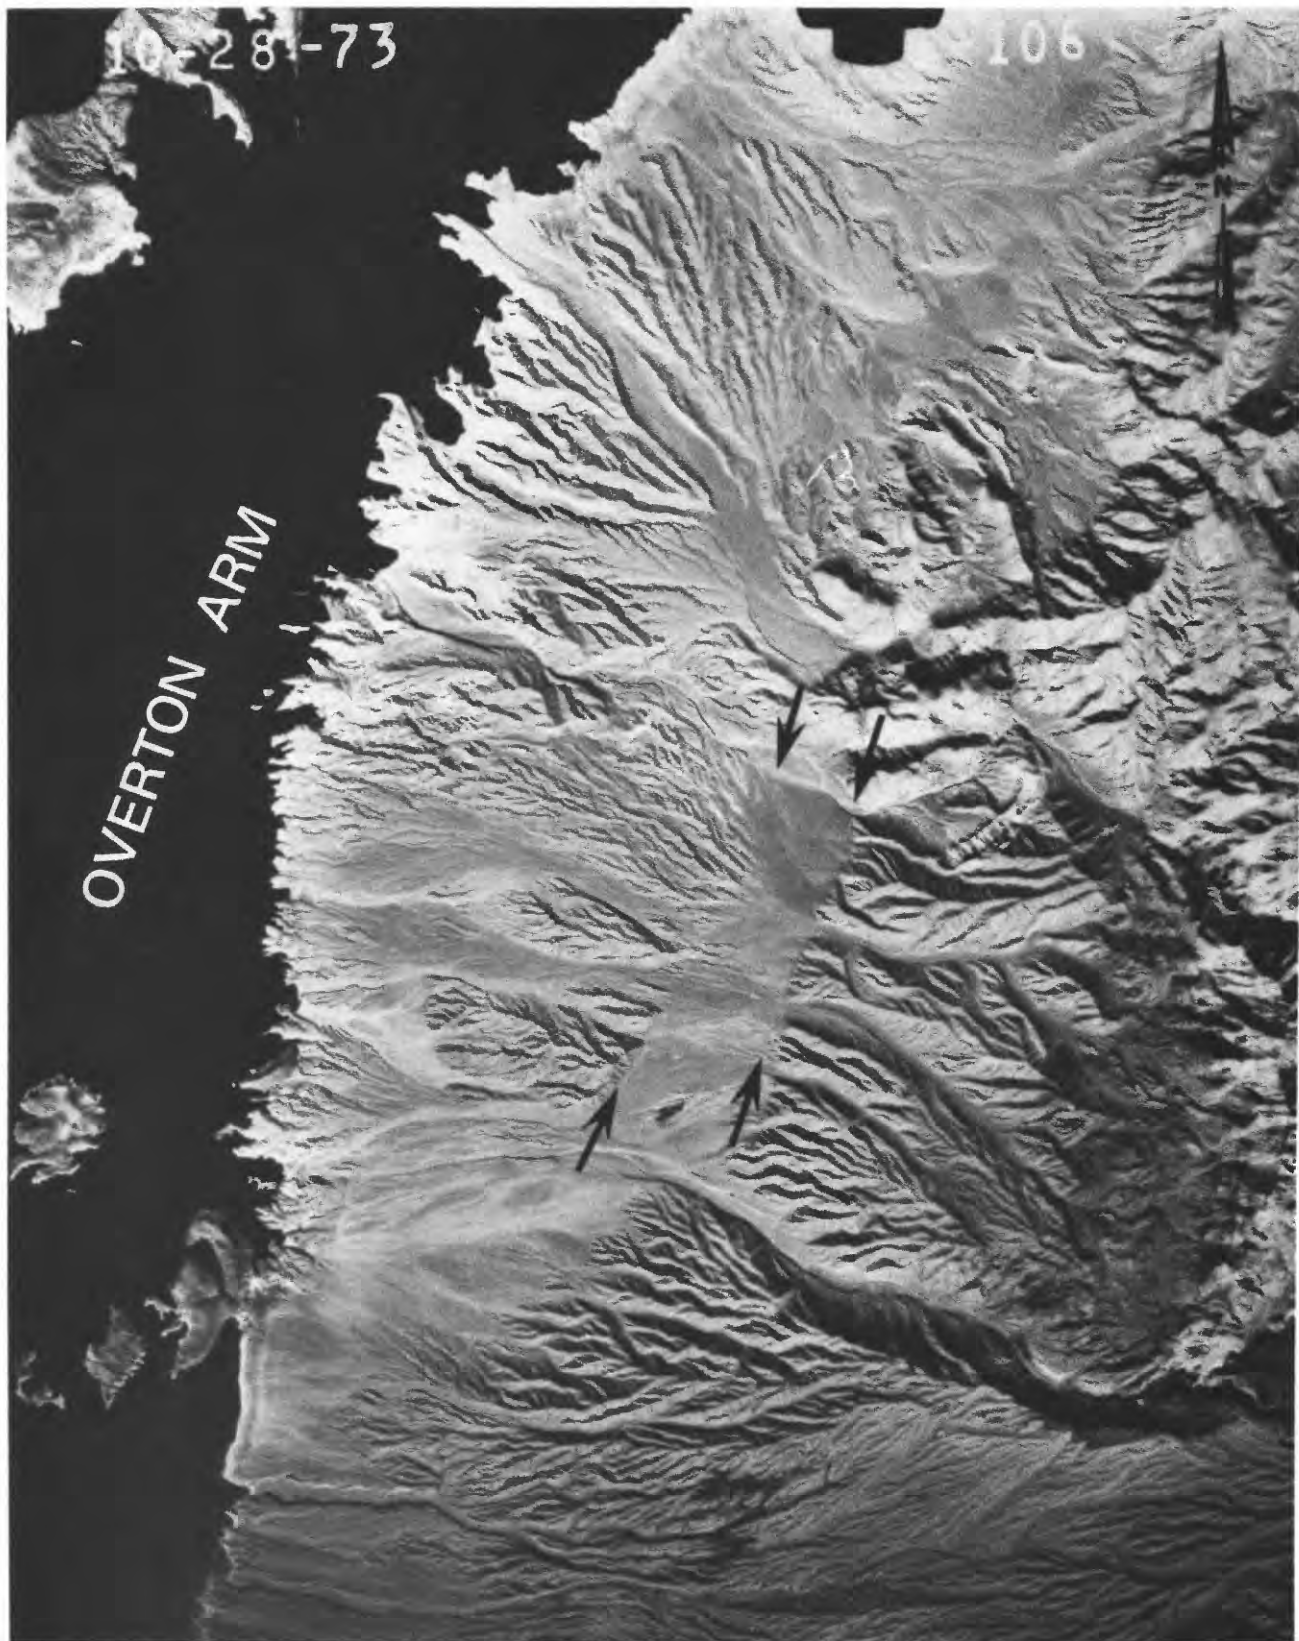
NOTE:
Lineaments indicated by arrows.

LIME RIDGE AREA
HOOVER DAM AND LAKE MEAD
Arizona and Nevada, United States
