Post-Earthquake Architecture at Olympia: The Impact of Natural Phenomena upon the Builders' Attitude in the 4th Century BC

Elena C. Partida

Hellenic Ministry of Culture and Sports

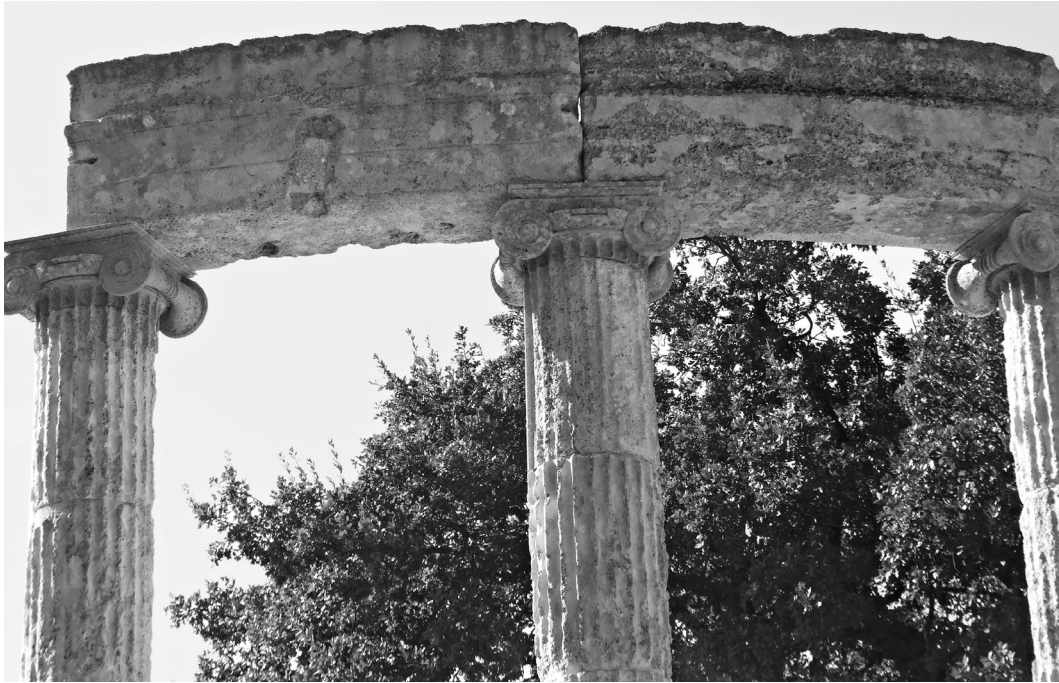
Figure 1. Part of the Philippeion epistyle at Olympia showing traces of repairs.

On its exterior the epistyle of the Philippeion features hooks⁴⁶ placed horizontally across vertical joints, to fasten cracked or adjoining blocks loosened apart (Fig. 1). Similar hooks mended the corner epistyle and triglyph of the temple of Zeus,⁴⁷ the frieze of the Echo stoa,⁴⁸ and perhaps also pedimental sculpture at Delphi.⁴⁹ The 'patch' on the Philippeion epistyle, no different from a 'patch' in the limestone temple of Athena Pronaia,⁵⁰ probably represents another ancient repair. These consolidation operations could be concealed under a coat of fine

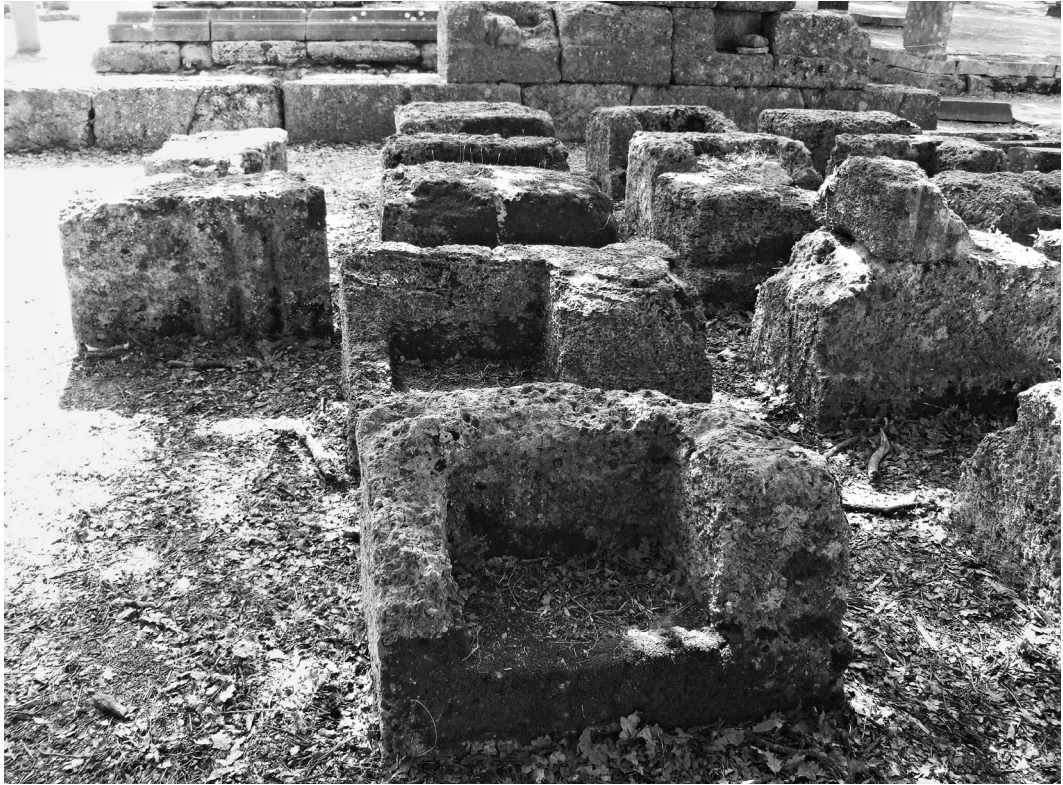
Figure 2. Triglyph-blocks from the Echo stoa at Olympia with roof-beam sockets.

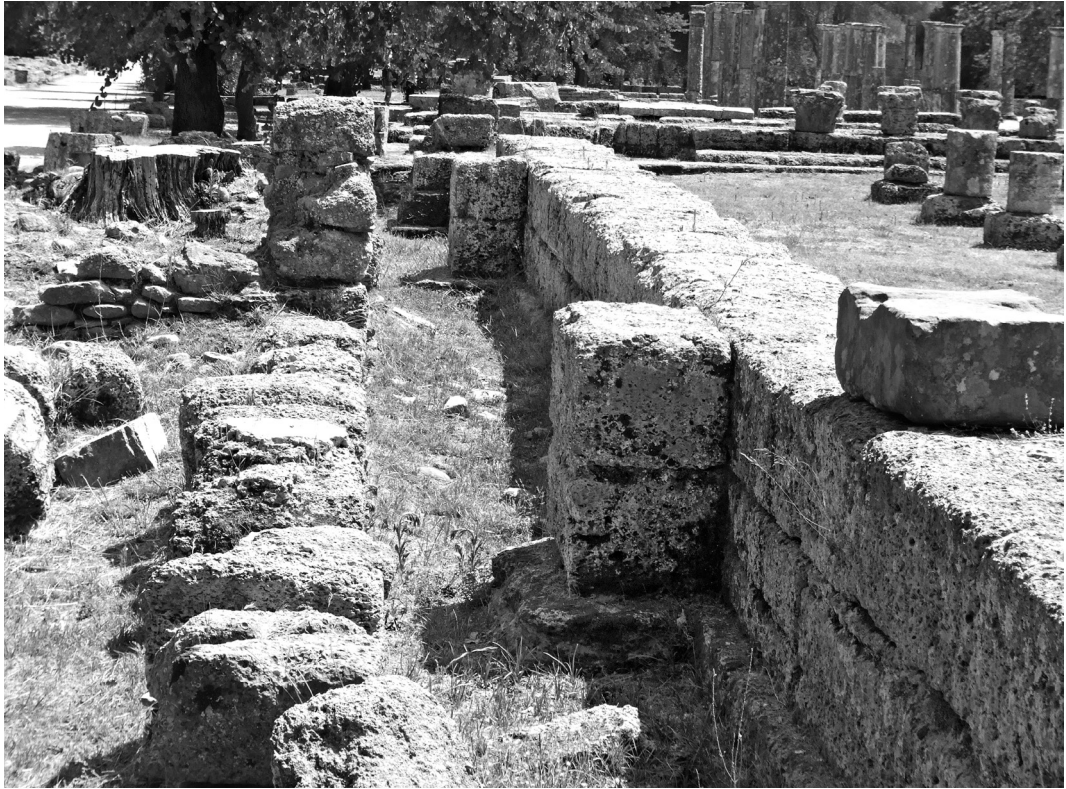
Figure 3. *Buttressed toichobate of the Gymnasium east stoa at Olympia.*

Despite the flat terrain at Olympia, buttresses were judged necessary after the 4th century BC. Along the outer side of the stone toichobate of the Gymnasium east stoa (perhaps a Hellenistic xystus) we notice projections at regular intervals, where the lowest stone-block was cut at a right angle, to form a projection and to support upper courses buttressing the stoa wall (Fig. 3).

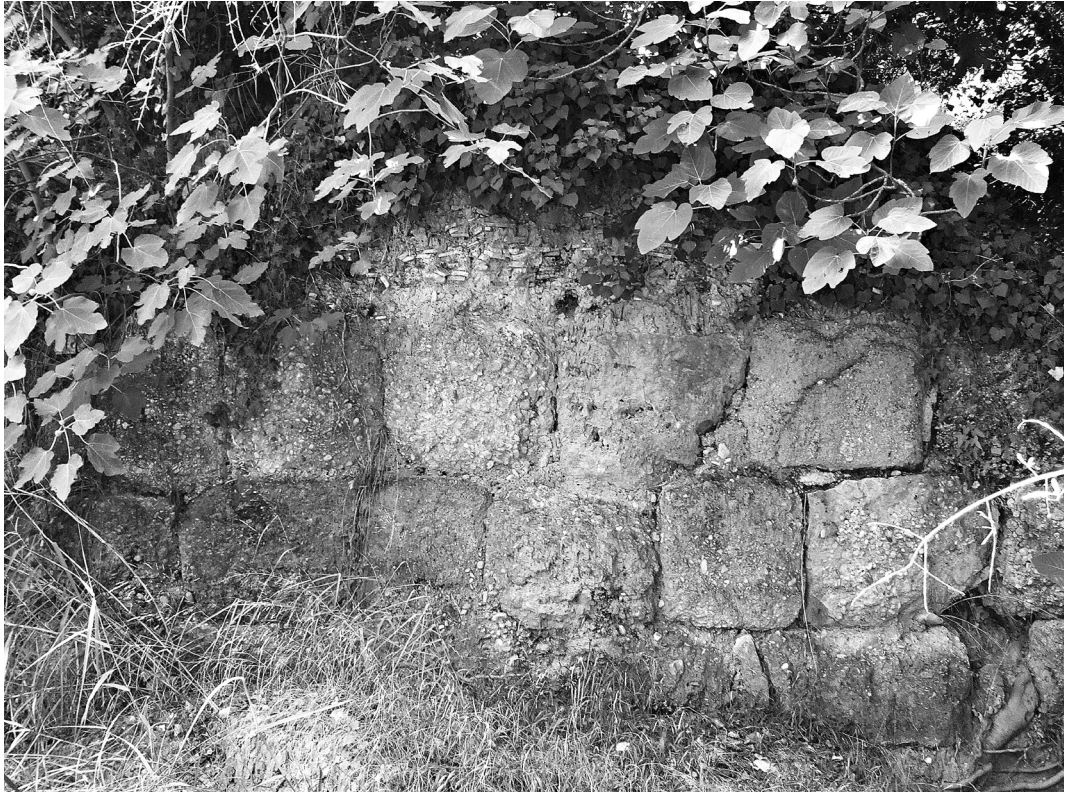
Figure 4. Detail of the Kladeos wall at Olympia.

We also notice that, despite the leveled ground at Olympia, ancient builders did use retaining-walls, all the more so, stepped. Hardly discernible is the stepped cross-section of the west retaining-wall⁵⁴ of the classical Stadium, later embedded in the foundations of the Echo stoa. At some points the Kladeos embankment-wall was stepped, too.⁵⁵ The treasuries' terrace-wall, built in the mid-4th century BC,⁵⁶ exemplifies the technique of a graded cross-section.⁵⁷ Worth noting are the traces of analemata behind -and slightly later than- the treasuries of Selinus, Gela and Sicyon,⁵⁸ which were also graded. Noting that dedicators held responsibility for the maintenance and repairs to their ex-votos,⁵⁹ we would argue that dedicators or commissioners originating from an area of seismic risk were more conscious of the danger.
